**MT-RAP-2008-00100/mso**

**Summary of coating surveys  
on the four air command frigates  
(Zeven Provinciën class)**

Date	March 26, 2008
Author	R. van der Kaaden, B.Sc. (TNO Quality Services B.V.)
Client	Ministry of Defence DMO / DWS / RZS / PLTFT Corrosion Prevention Attn. of Mr. H. Bakuwel, B.Sc. MPC 58 A P.O. Box 90822 2509 LV The Hague
Classification report	Unclassified
Classified by	H. Bakuwel, B.Sc.
Classification date	March 12, 2008
Title	Unclassified
Managementuittreksel	Unclassified
Abstract	Unclassified
Report text	Unclassified
Appendices	Unclassified
Copy no	18
No. of copies	22
Number of pages	40
Number of appendices	1

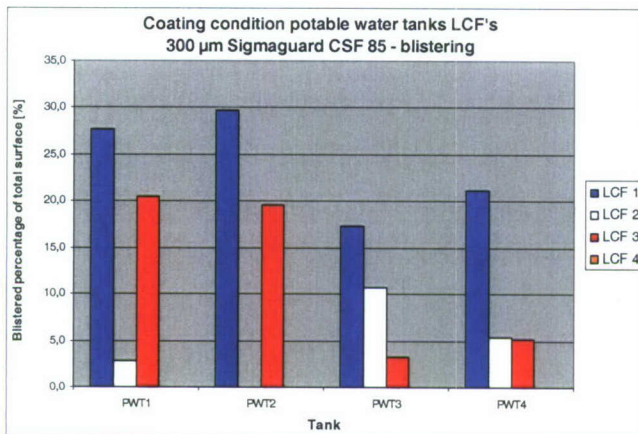
Graph 1: Blistering in potable water tanks

- It has been observed in several tanks that corrosion has set in and originated from pinholes in the coating. Solvent free coating systems are more susceptible to pinhole formation compared to solvent containing systems. Pinholes within the coating system have not been repaired adequately during the preservation of the tanks.

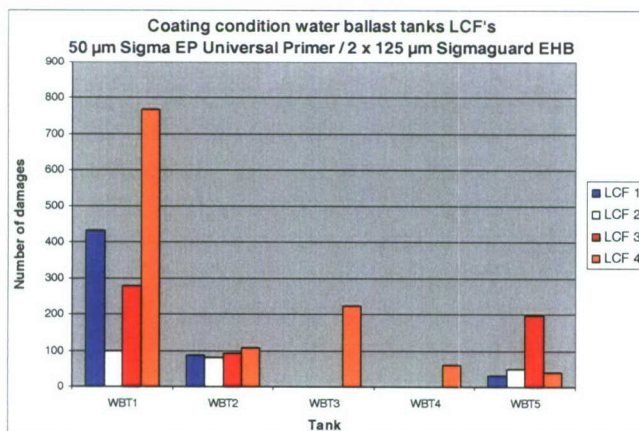
Graph 3: Number of defects in water ballast tanks

- Anodes have been mounted on a height of approx. 1 m from the deepest point in ballast tanks 1. This implies that the cathodic protection does not work when water levels are relatively low.

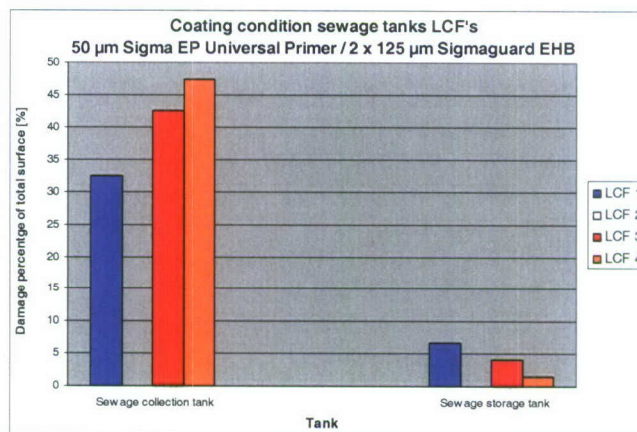
Graph 5: Affected surface percentages in sewage tanks

- Especially in the collection tanks, significant areas have been affected by blistering (photo 7). On LCF 4, the first frigate to be inspected, blistering had occurred in various places within the coating system. Subsequent inspections on LCF 1, 2 and 3 proved that blistering is a structural problem.
- Blistering has also occurred in the sewage storage tanks though to a far lesser extent.
- Both in the sewage collection and storage tank, corrosion is limited to a few spots (photo 8). As far as could be assessed, deep steel wastage has not occurred.
- The extremely poor condition of Cunifer piping in the tanks of LCF 1 (perforations) was striking (photo 9). GRP piping has been installed instead on all LCF's.

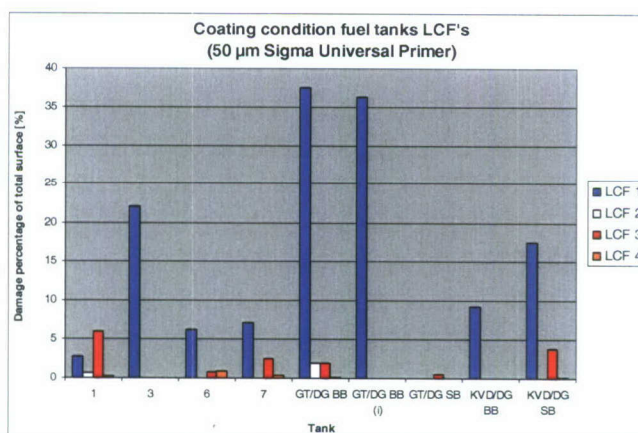
Graph 6: Affected surface percentages in fuel tanks

- In some tanks on LCF 3, several layers of coating have been applied on places and blistering and detachment has occurred between individual coating layers.

The graph illustrates that fuel tanks on LCF 1 have been affected to the highest level. This is due to the fact that areas in tanks on this LCF have not been coated completely.

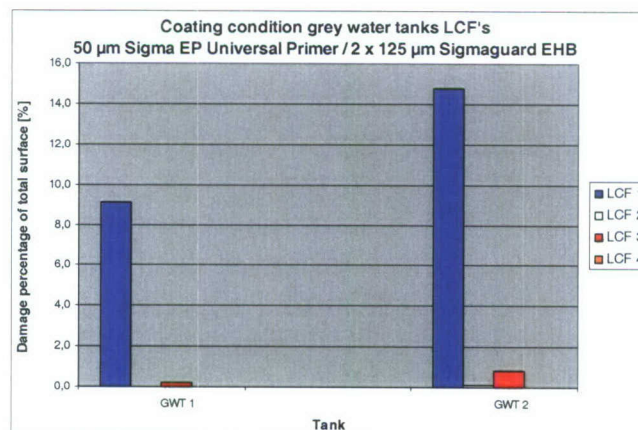
Graph 7: Affected surface percentages in grey water tanks

- Generally, the coating condition in tank 1 is significantly better compared to the condition in tank 2. This must be due to conditions inside the tanks. Grey water tank 2 is used for galley water which can be aggressive as a result of fatty acids.
- Grey water tank 2 on LCF 1 is by far in the poorest condition (photo 14). Signs of breakdown though have been observed on LCF 2 and 3 as well.
- In time the coating system in grey water tank 2 is damaged, weakened and disappears.
- Besides the general breakdown, minor damages have been a result of pores in welds, cracks in a thick coating layer and mechanical damages.
- Typically, repaired spots in grey water tank 2 on LCF 3 have developed blisters.

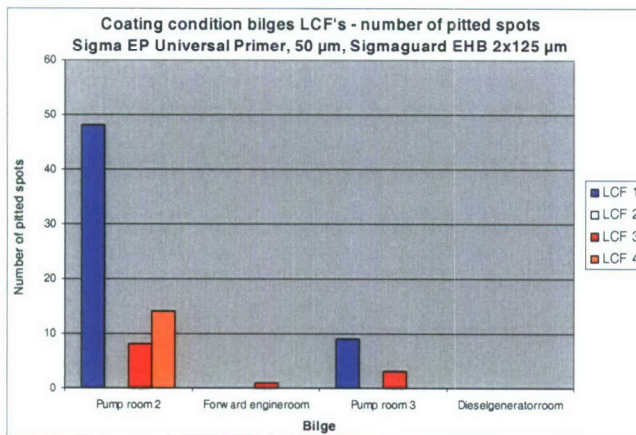
Graph 8: Number of pitted spots in bilges

- On all LCF's, pitting corrosion has been observed in bilges, especially in pump rooms 2 and 3 (photo 18). The depths of the pits varied from approx. 1 mm up to 6-7 mm.
- A black substance was present in the pits.
- Additional investigations have been carried out into the cause of pitting in pump room 2 on LCF 1. Sulphur reducing bacteria have been identified, as well as fungi. Sulphur reducing bacteria can result in pitting corrosion. Access to the steel was possible due to the mechanical damages.
- As can be expected in bilges, the coating system frequently shows corrosion as a result of mechanical damages. Additionally metallic particles are present on the coating surfaces, which develop corrosion.
- Cracks due to high coating thicknesses sometimes reaching the steel resulted in penetrating corrosion.
